Inspection Report Minerals Regulatory Program

Mine Name: Papoose Operator Name: Cotter Corporation	Permit number: M0370084 Inspection Date: August 29, 2006 Time: About 5:15-6:30 PM Weather: Clear, 70s		
Inspector(s): Paul Baker Other Participants: None Mine Status: Active			
Elements of Inspection	Evaluated	Comment	Enforcement
 Permits, Revisions, Transfer, Bonds Public Safety (shafts, adits, trash, signs, highwalls) Protection of Drainages / Erosion Control Deleterious Material Roads (maintenance, surfacing, dust control, safety) Concurrent Reclamation Backfilling/Grading (trenches, pits, roads, highwalls, shafts, drill holes) Water Impoundments Soils Revegetation Air Quality Other Purpose of Inspection: This was a routine inspection. 			
Inspection Summary:

M0370084, Papoose Mine, Cotter Corporation

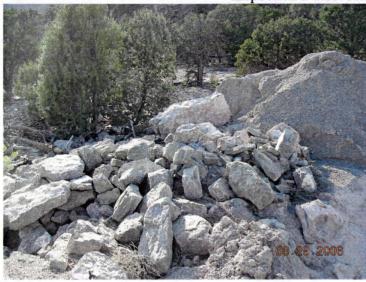
At the northwest corner of the mine, the operator has installed a sediment trap. The outlet had a silt fence, but the operator has now placed several large rocks at the outlet. The silt fence was a maintenance problem and seemed to fail frequently, but the rocks should help that situation.

Photo 1. Rocks at the outlet of the sediment trap at the northwest corner of the mine.

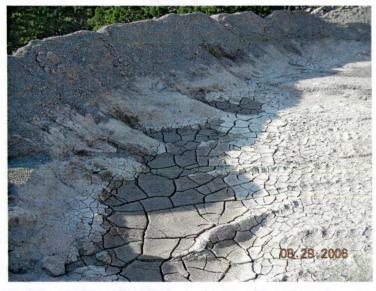
Photo 2. The sediment trap.

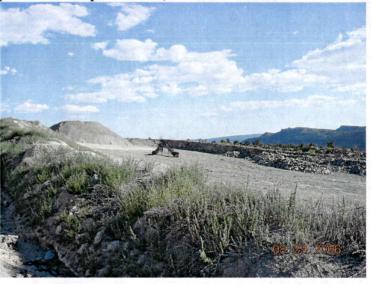
Soils are stockpiled on the northeast and southwest sides of the mine, and the operator has recently been clearing a new area and stockpiling these soils. Vegetation on the soil stockpiles consists almost entirely of Russian thistle.

Photo 3. One of the soil stockpiles is in the foreground.

The operator needs to try to establish perennial vegetation on the soil stockpiles. I suggest that the stockpiles be roughened and seeded either in the fall or early in the spring.

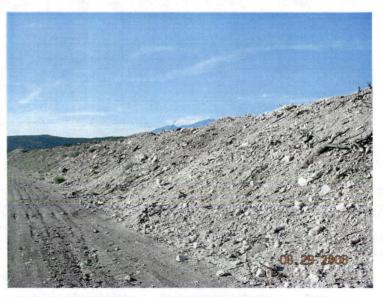
Photo 4. Soil that has been recently stockpiled.

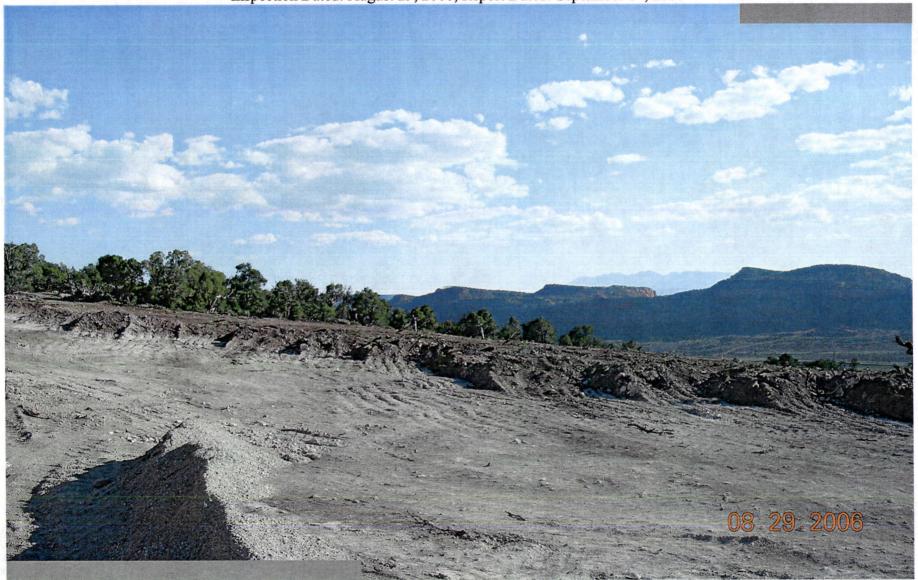
Photo 5. The new area being cleared.
